Phase IV Jet Propellant (JP)-8

Fuel Performance Test

XM20 Bridge Erection Boat (BEB)

ATEC Project No. 2007-DT-ATC-XM22B-D7353
Type Test and Title: Phase IV Jet Propellant
(JP)-8 Fuel Performance Test of the XM20
Bridge Erection Boat (BEB)

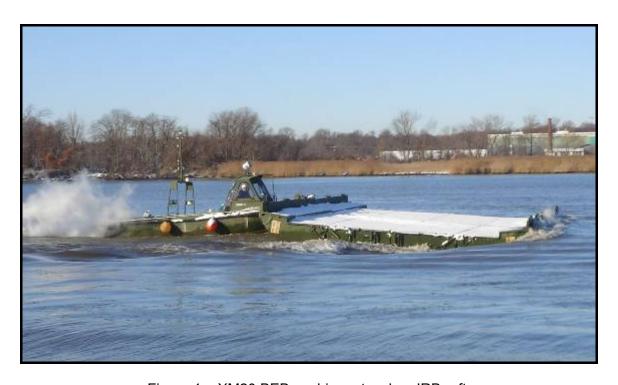
The primary mission of the bridge erection boat (BEB) is to assist U.S. Army Multi-Role Bridge Company (MRBC) units in maneuvering, construction, and operation of the improved ribbon bridge (IRB) during bridging and rafting operations (fig. 1). As a secondary function, the BEB can be used for safety boat, troop and cargo transport, and patrol and reconnaissance missions. The BEB is a 27- by 8-ft aluminum hull, twin engine, twin hydrojet powered vessel. The XM20 BEB is powered by twin Cummins 6BTA 5.9-L, six-cylinder, four-cycle 260-hp marine diesel engines equipped with in-line fuel injection pumps.

Figure 1. XM20 BEB pushing a two-bay IRB raft.

- (1) Simulated rafting full throttle operation for 37 min while pushing a two-bay IRB raft in the conventional configuration (fig. 1).
- (2) Induced aeration cycles were conducted for 3 min. From full throttle, full forward control, the driver moved the throttle controls to low idle, shifted the buckets to the full rearward position, and then immediately increased the throttles back to full revolutions per minute (rpm). While backing under full throttle, the operator immediately and quickly moved the throttles to minimum idle. The operator waited for the engine speed to reduce to minimum, and then the throttle was increased to half throttle to determine if the engines remained at idle or stalled, independent of throttle position. The engine(s) were restarted as necessary.
